NBSIR 82-2593

Investigation of Construction Failure of the Riley Road Interchange Ramp, East Chicago, Indiana

October 1982

N. J. Carino
H. S. Lew
W. C. Stone
R. M. Chung

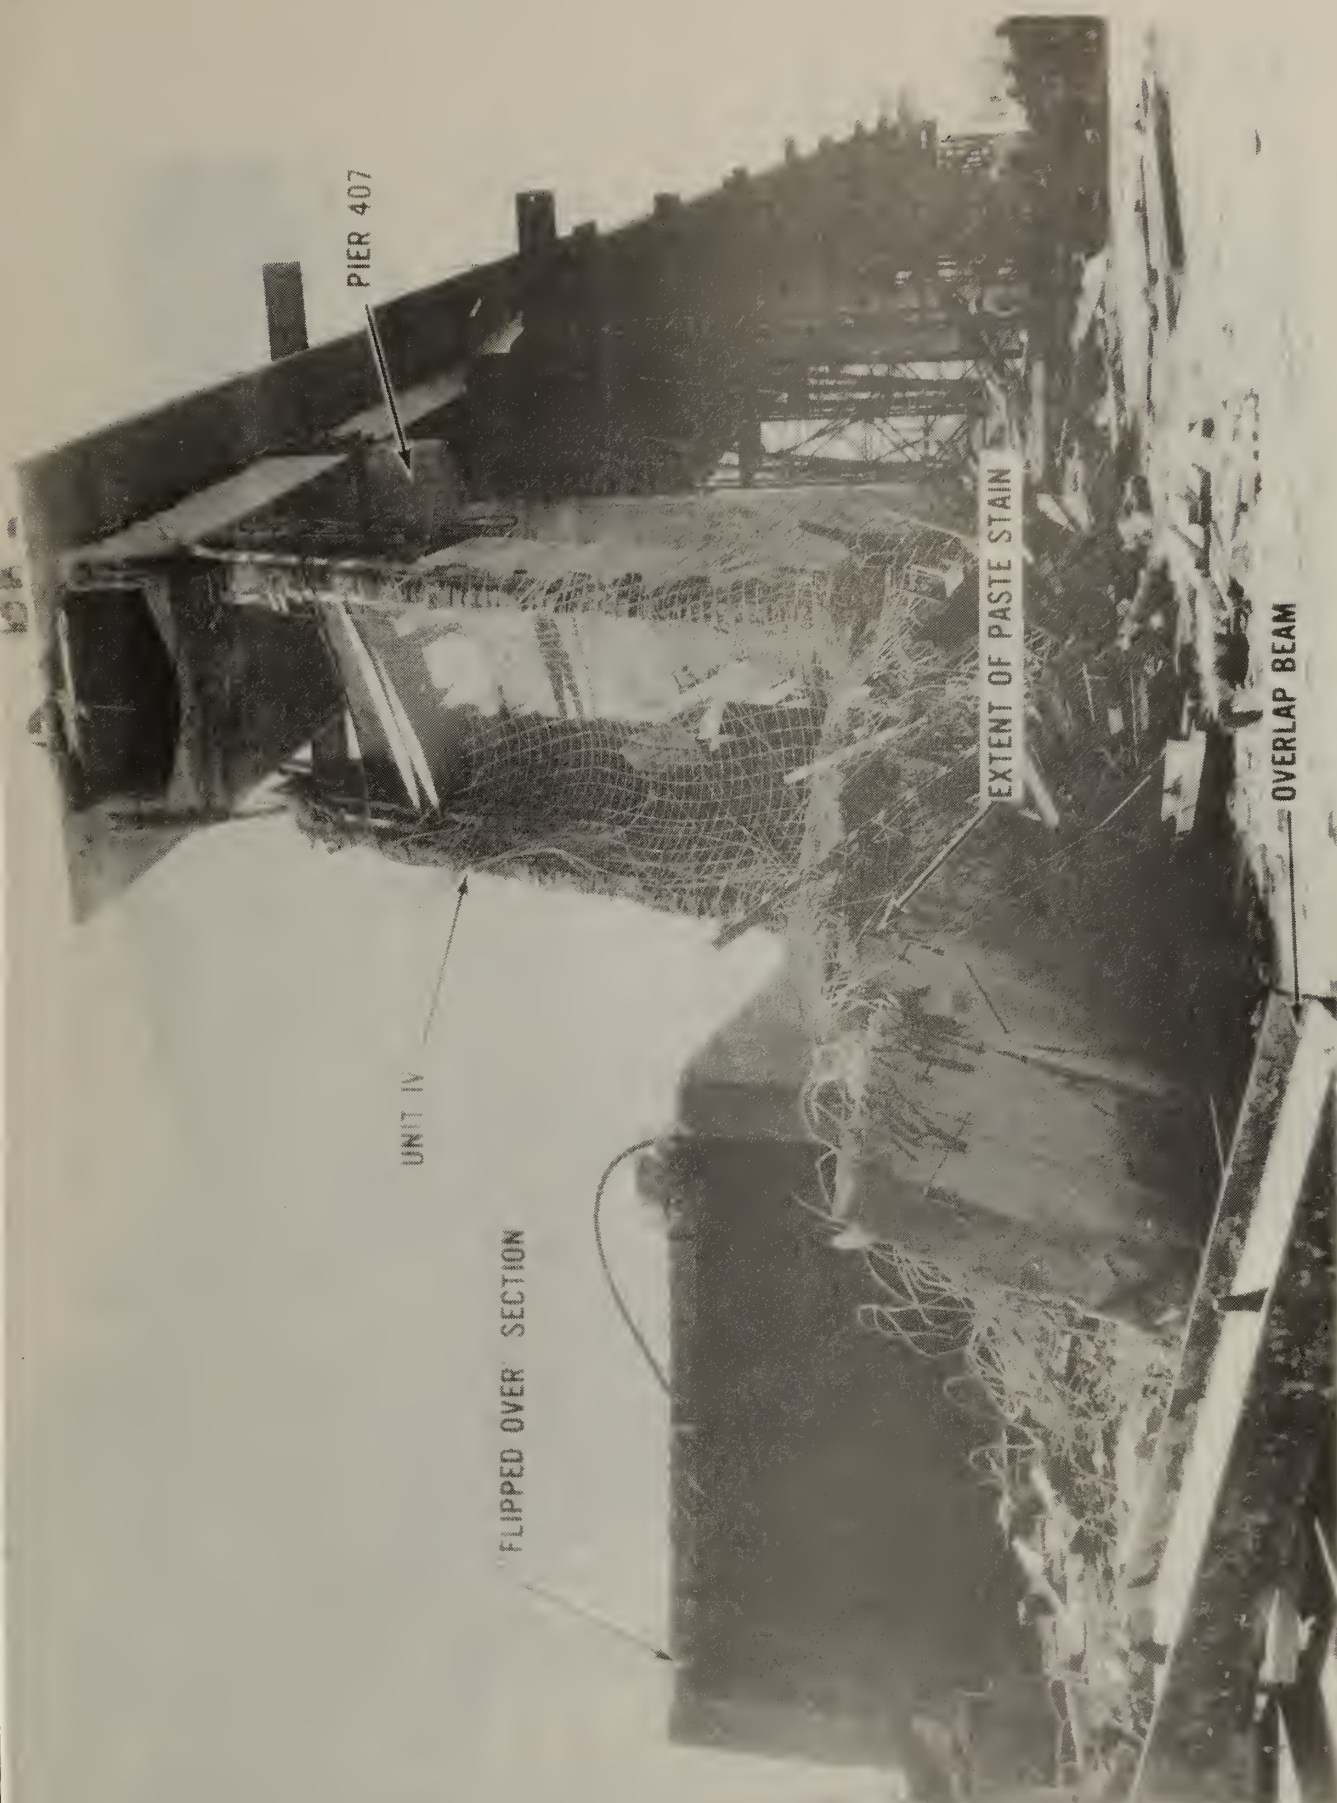
concrete plant, 140 yd³ (107 m³) of concrete had been delivered for the top slab. From field measurements it was found that the diaphragm had been filled to an elevation of about 5 ft (1.5 m), thus it was calculated that the top slab had been placed to a point about 20 ft (6.1 m) west of pier 408, when the collapse initiated. This estimate was corroborated by worker statements and by measurements of the extent of the cement paste stain on the northern side wall of unit IV (see figure 2.17).

Figure 2.17, 2.18, and 2.19 are ground level views of unit IV. Figure 2.17 is a view from the northeast and shows the portions of unit IV that were adjacent to pier 408. Stains due to fresh cement paste can be seen on the northern side wall. The stained region ends at about 20 ft (6 m) from the end of the unit, and this is assumed to indicate how much of the top-slab concrete had been placed. In the foreground of figure 2.17 is seen a short, steel beam that was originally located next to the cap of pier 408. The purpose of this beam is discussed in subsection 3.2.4.

Figure 2.17 Unit IV as viewed from the northeast

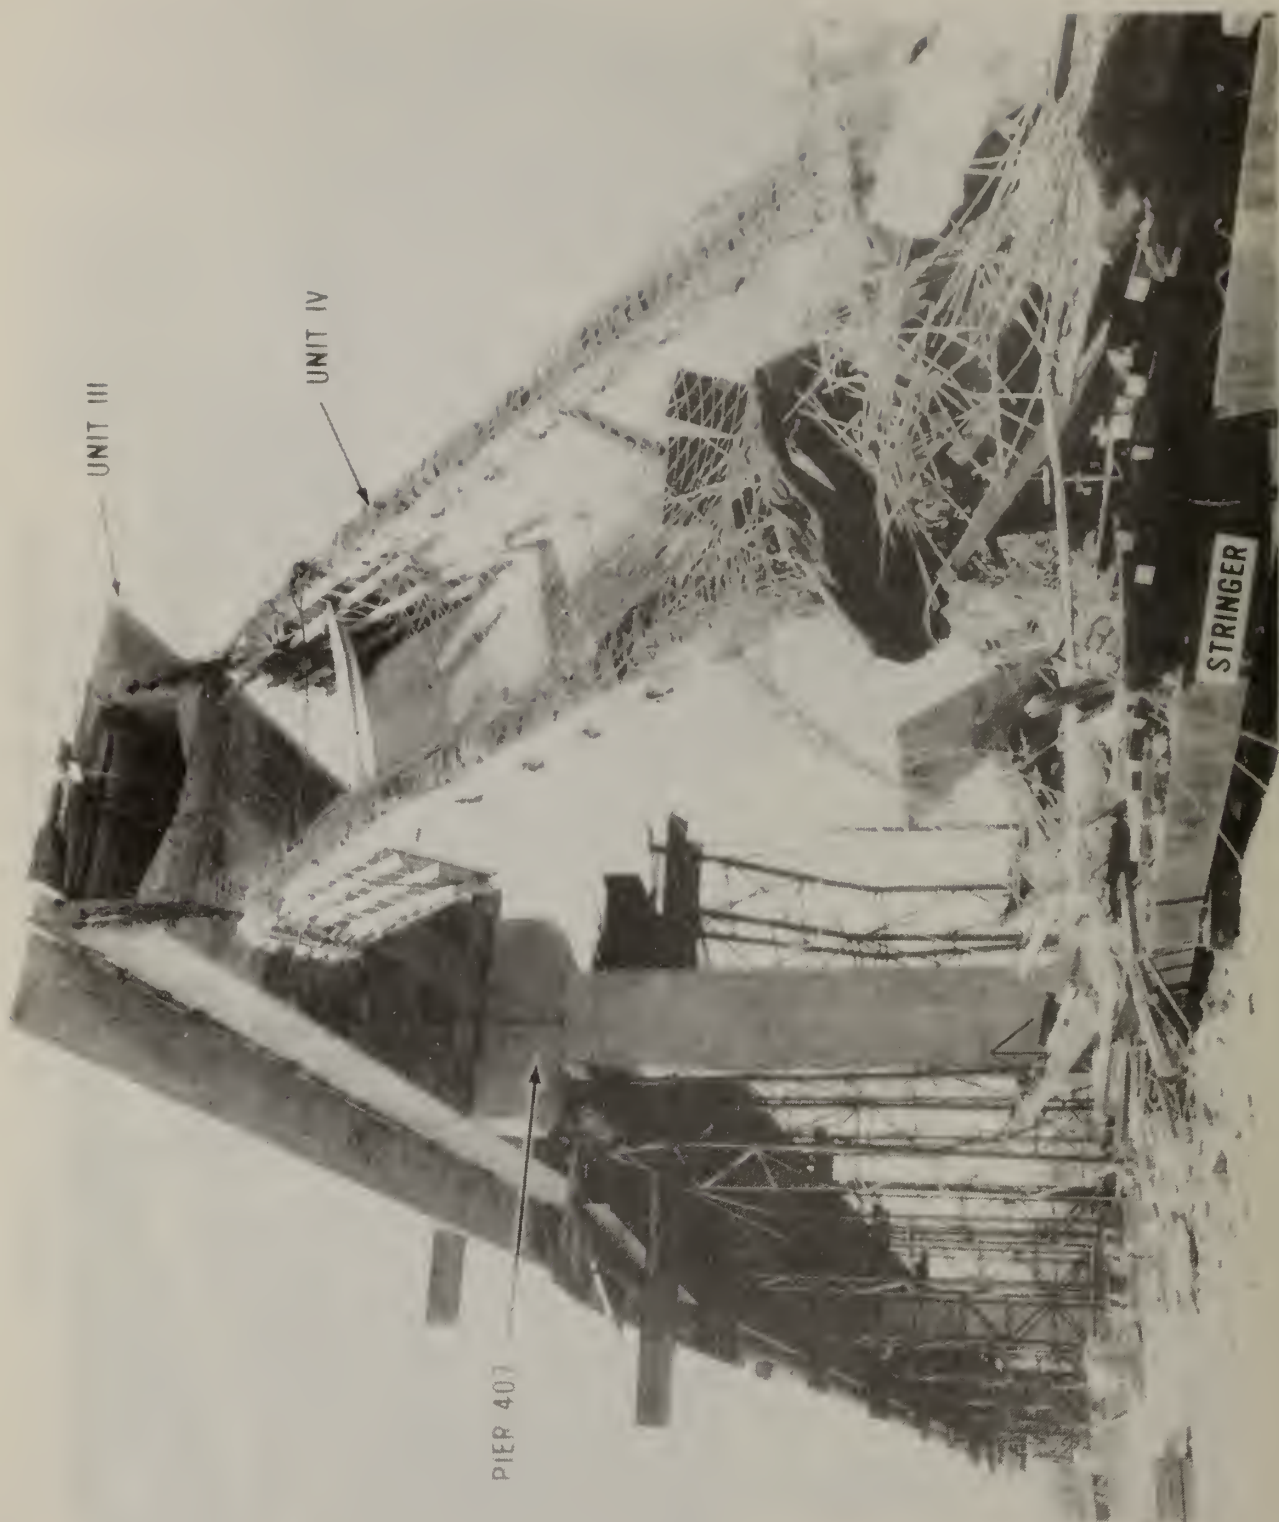
Figure 2.18 Partial view of unit IV from the southeast

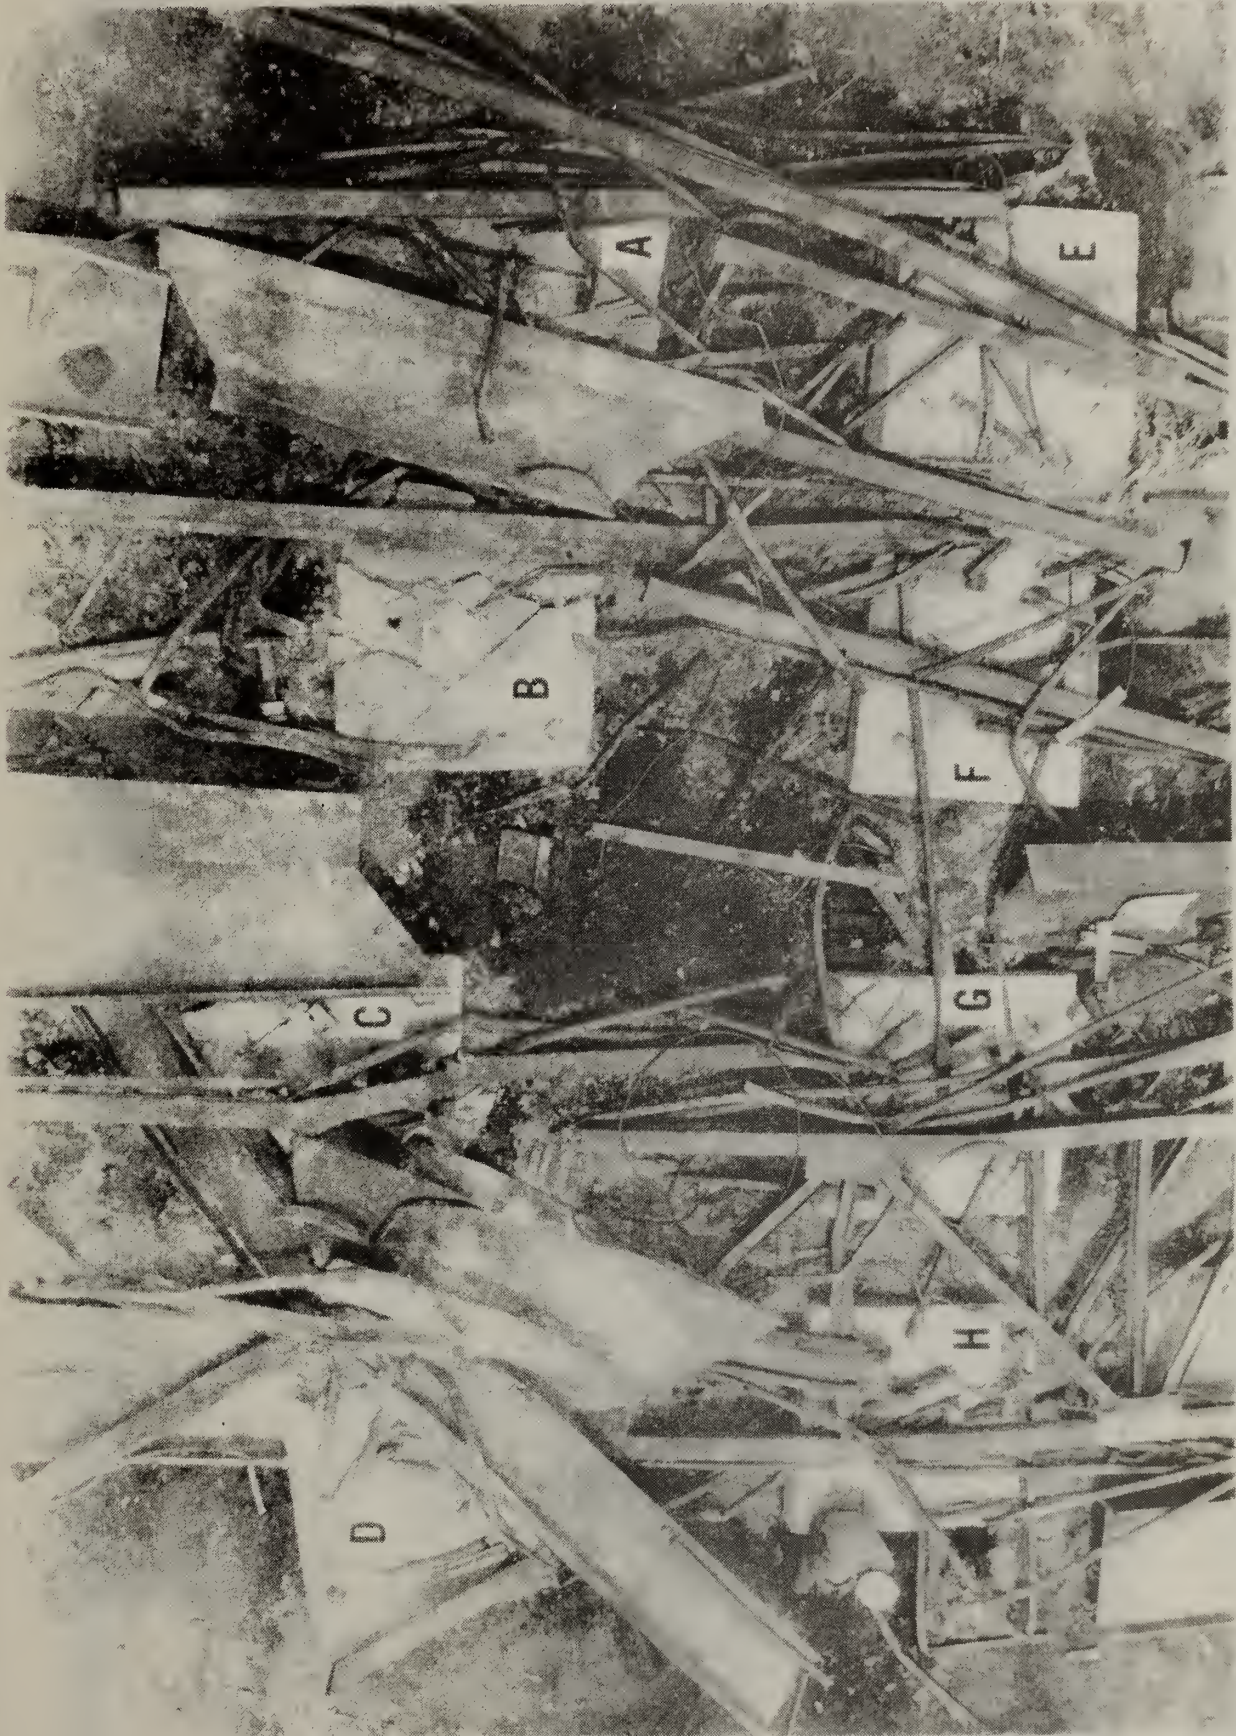
Figure 3.24 Close-up view of cracked concrete pads at tower location 407.2 (north is to the right)

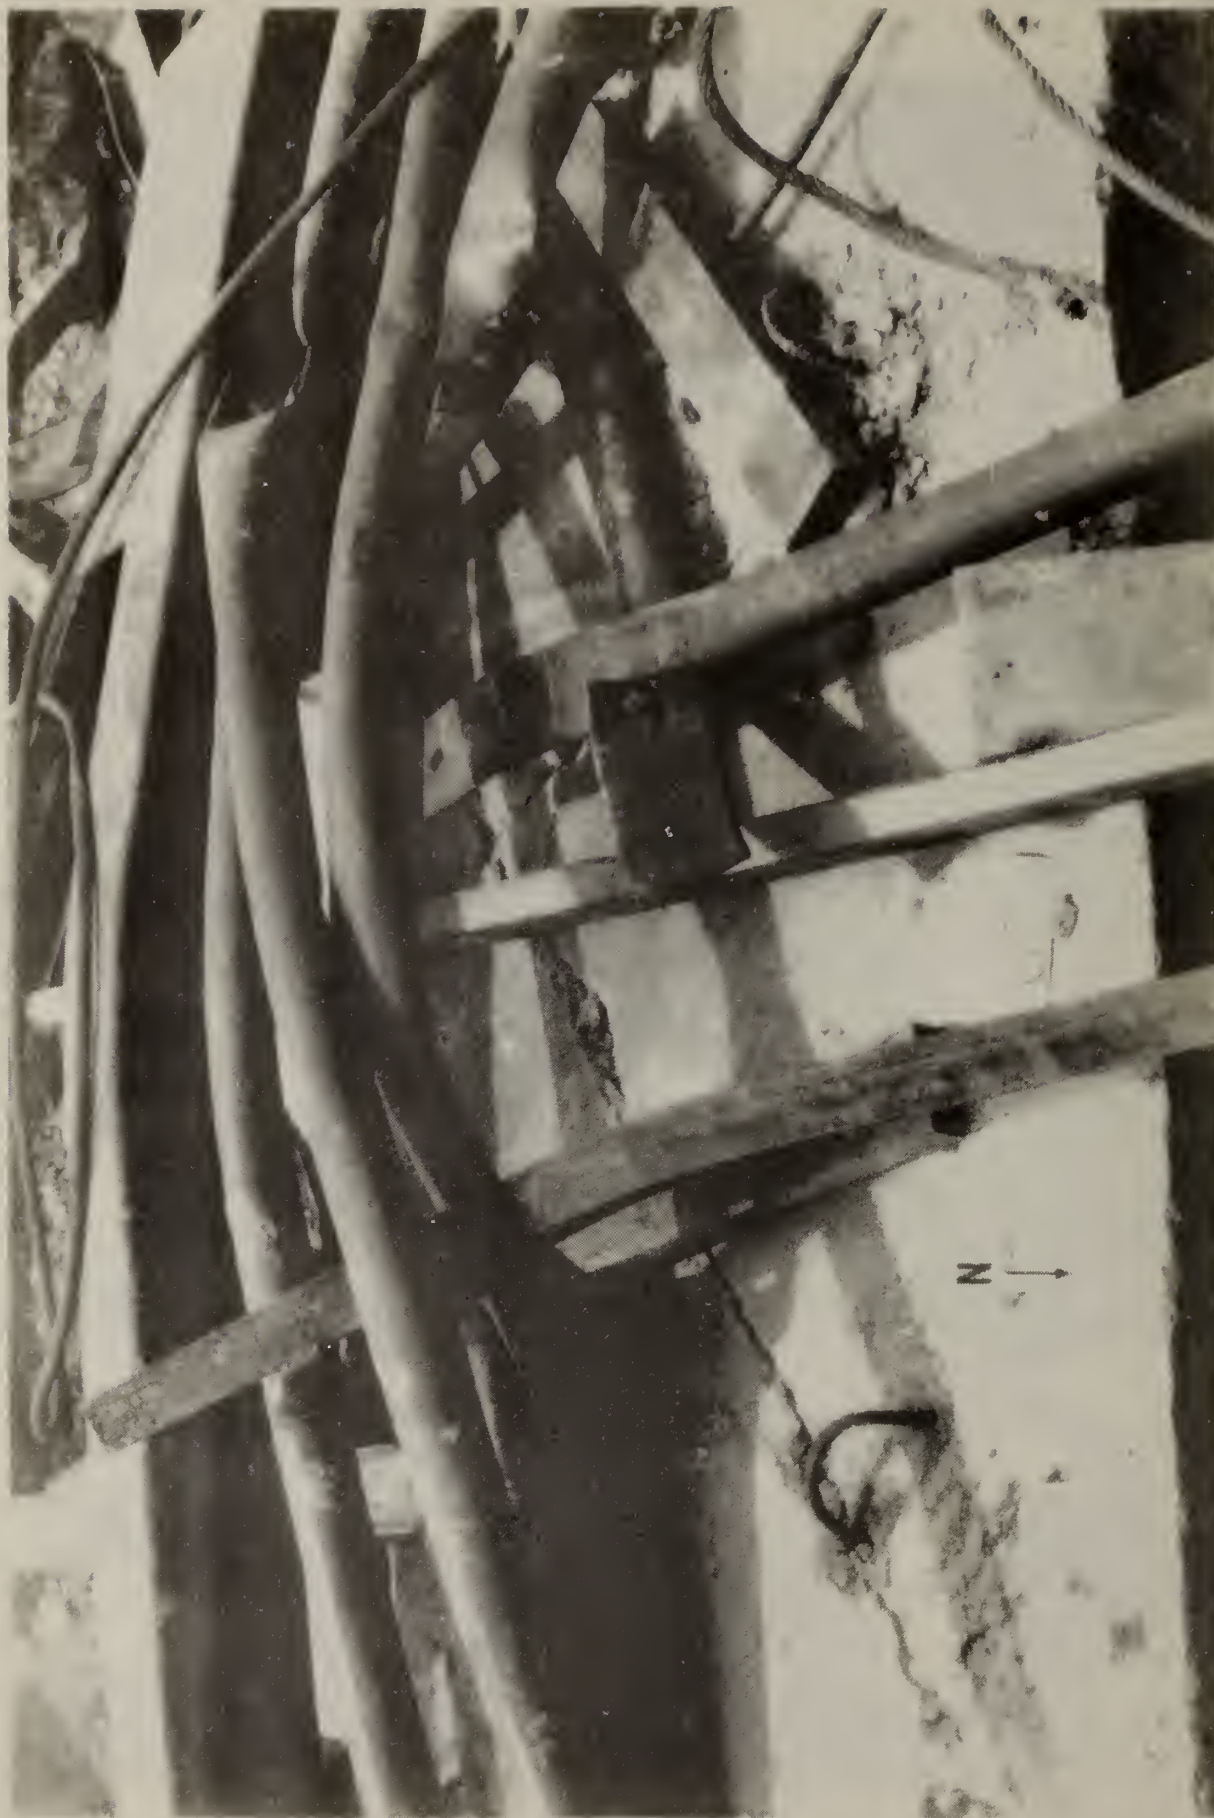
Figure 3.25 Cracking pattern of concrete pad 407.2-G

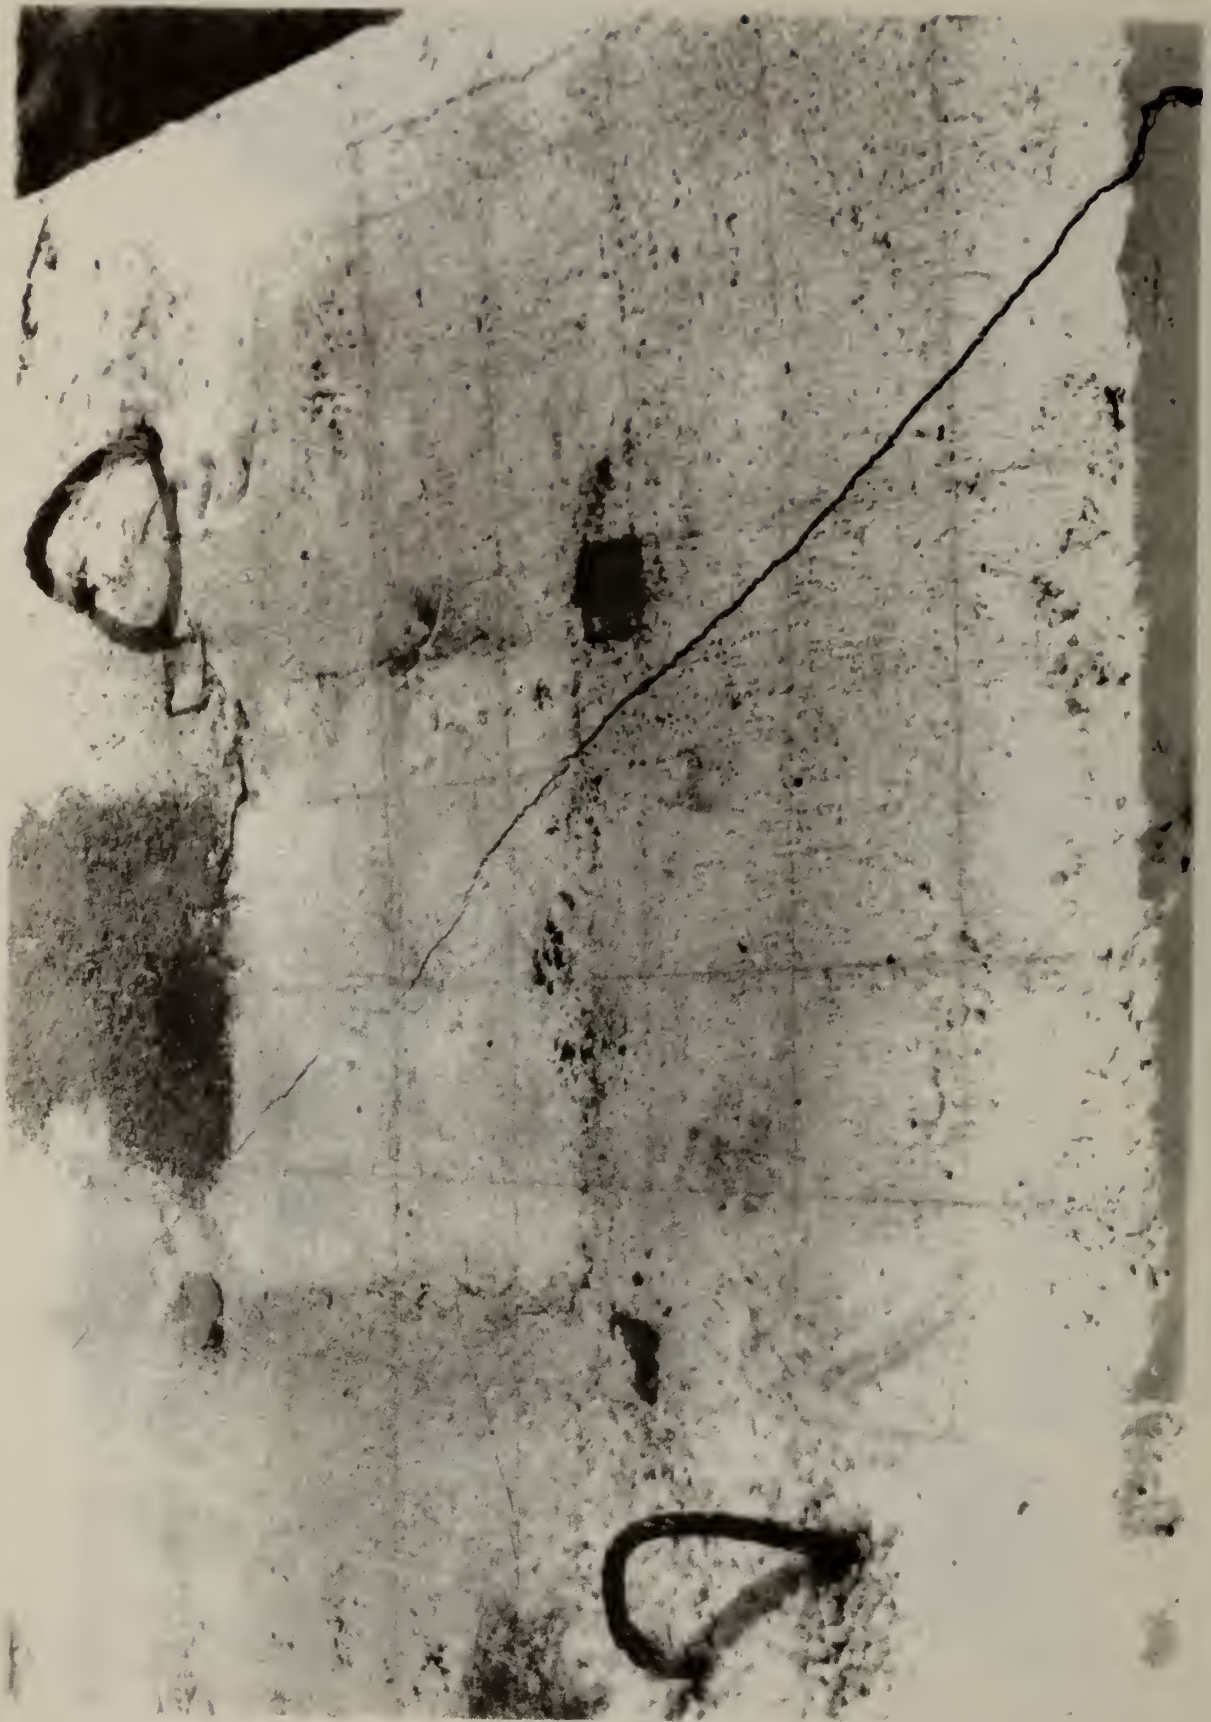
Figure 4.41 Pad crack pattern: diagonal
